NATIONAL TRANSPORTATION SAFETY BOARD

HAZARDOUS MATERIALS ACCIDENT REPORT

DERAILMENT OF
A CSX TRANSPORTATION FREIGHT TRAIN
AND FIRE INVOLVING BUTANE
AKRON, OHIO
FEBRUARY 26, 1989

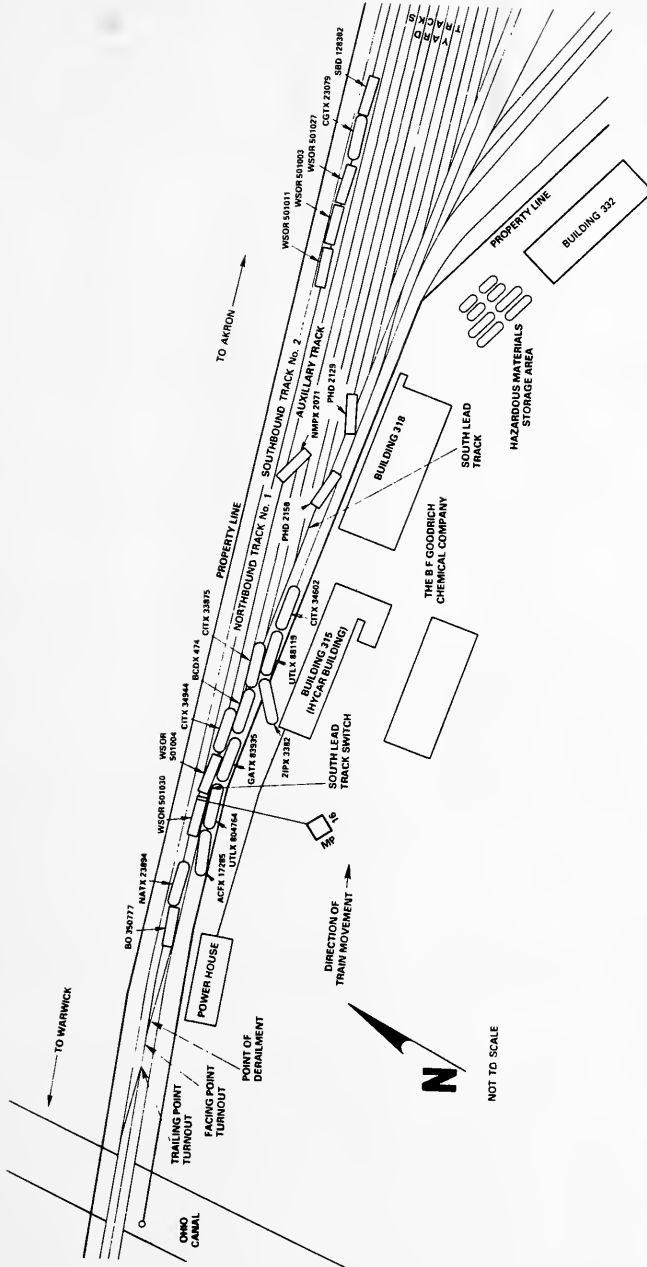
Figure 3.--The accident site.

The accident occurred near a B.F. Goodrich Chemical Company plant, and several tank cars of butane came to rest adjacent to B.F. Goodrich's building number 315 (figure 3). One of these tank cars (UTLX 88119) lost all of its butane (about 30,000 gallons) after sustaining a tear 15 feet 9 inches long in its sidewall. A second tank car (CITX 33875) lost butane through a 13-inch crack in its sidewall. A third tank car (ZIPX 3382) leaked butane through a valve in the dome. Tank car ZIPX 3382 was overturned and rested about 5 feet from the northwest corner of building 315; the tank car's pressure relief valve was obstructed by the ground and the car was involved in fire. Building 315 was 75 feet from the northbound track.

Building 315 housed a B.F. Goodrich latex manufacturing operation. That operation involved the use of acrylonitrile, butadiene, and styrene monomer, which were stored in tanks nearby (see figure 3). Additionally,

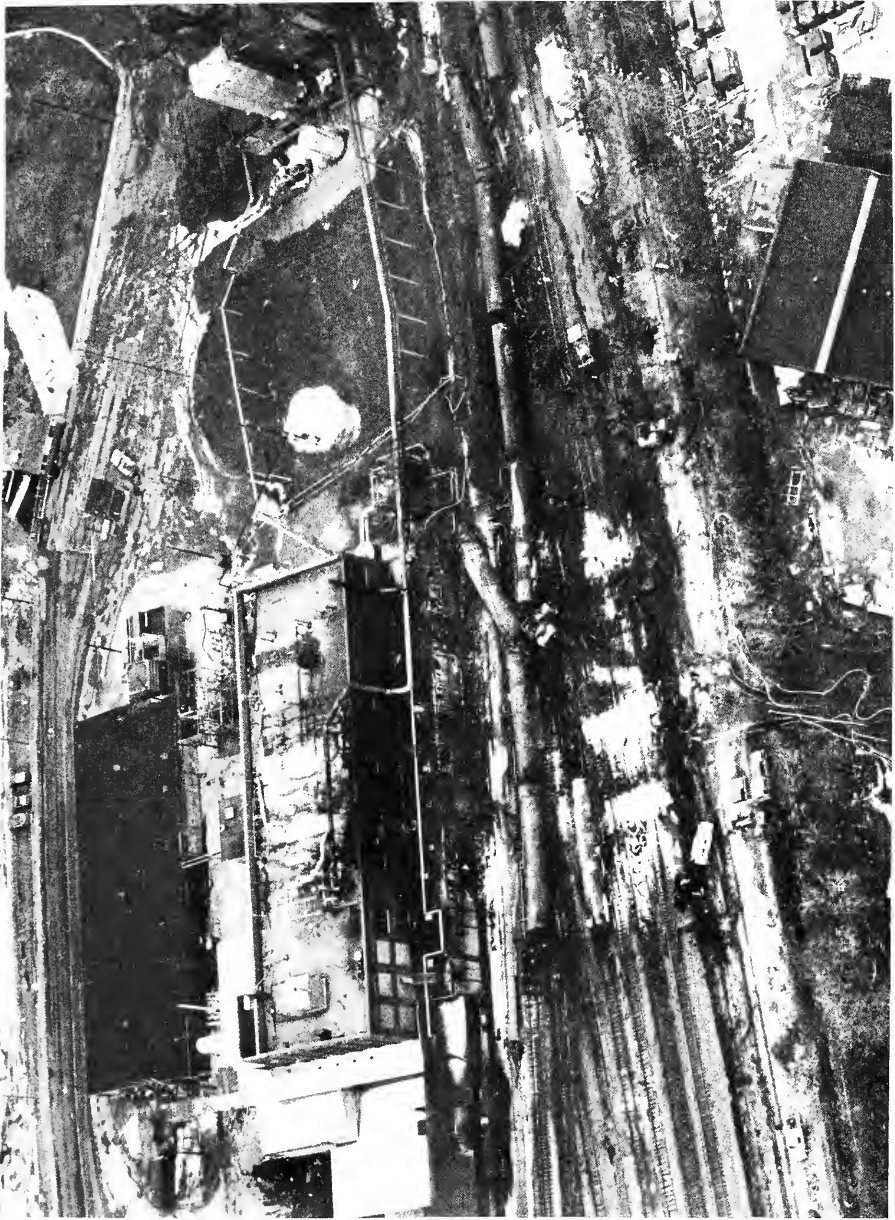
Figure 6.--Aerial view of derailment site. Some tank cars had been moved during wreckage clearing operations.

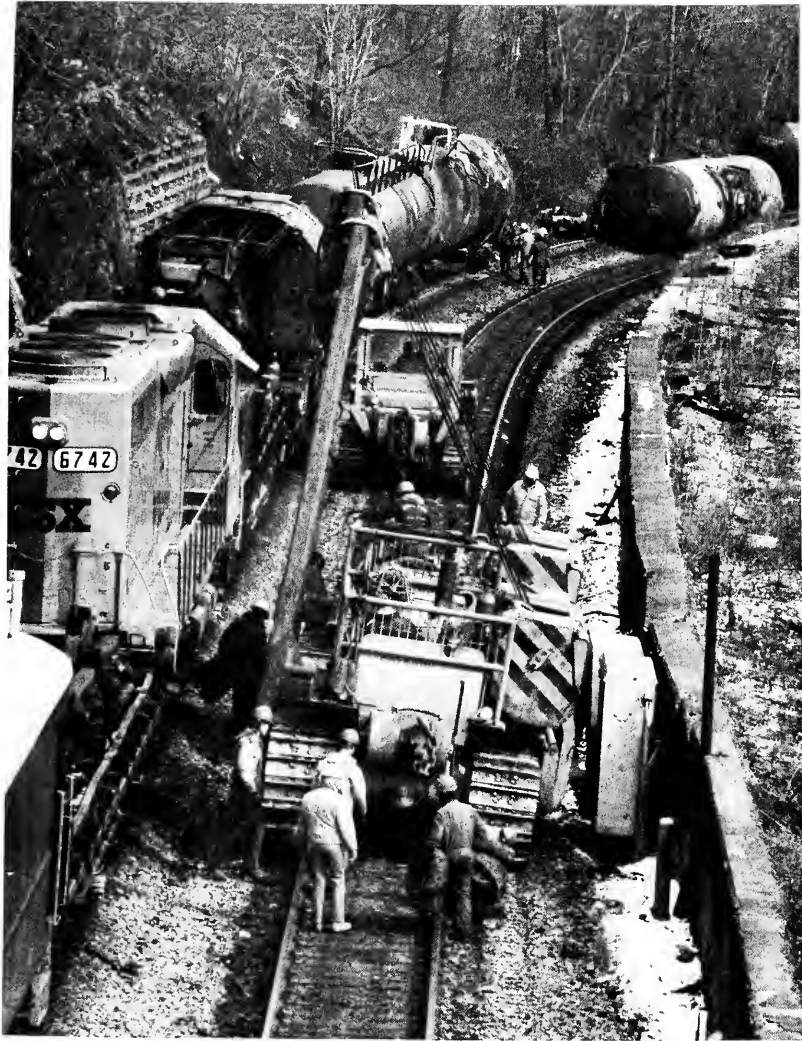
Figure 8.--Site of second event.

As the train began to move a third time, two CSX employees and a Conrail employee walked beside the train to observe the tank cars. About 7:55 a.m., the train entered a long, superelevated curve;²⁹ about 1/4 mile into the curve (about 3 1/2 miles north of the original accident site), the crew observed tank car ZIPX 3382 rock and then roll off its trucks and onto the ground between the two mainline tracks (figure 8). A body bolster on the leading end of the car, supporting the tank car on the truck, had broken. A CSX supervisor within 30 feet of this tank car said there had been no warning of trouble.

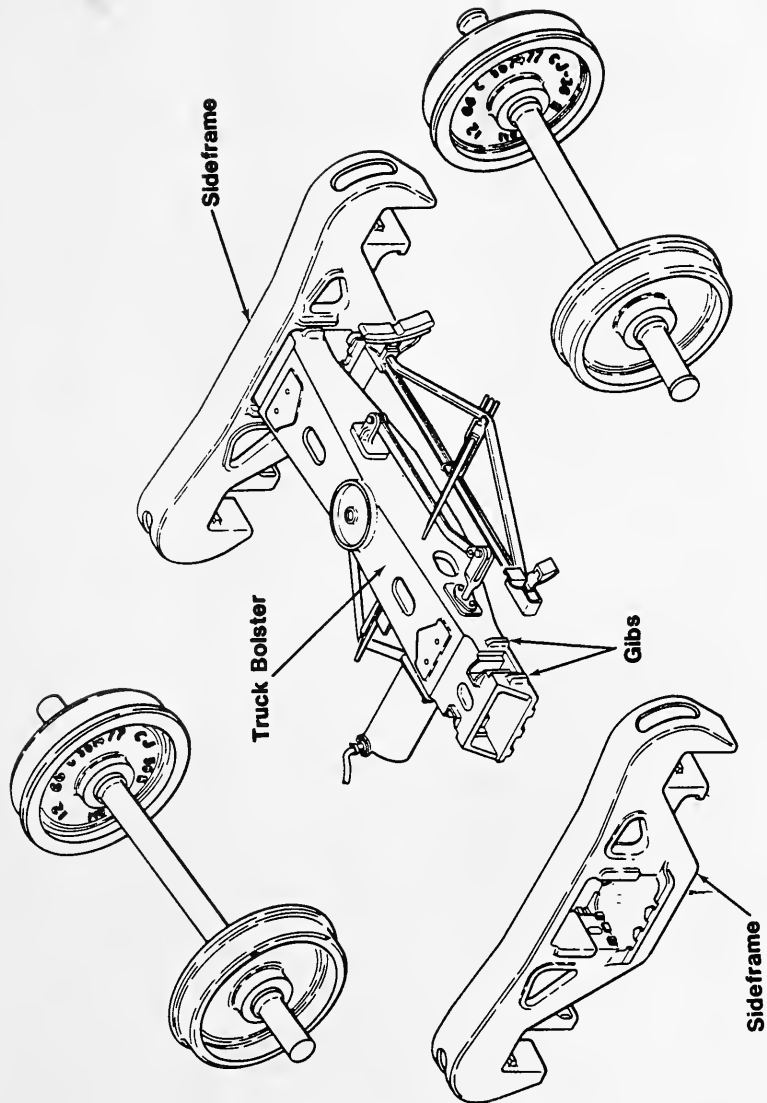
Figure 13.--Pertinent components of truck assembly.

After the derailment near the B.F. Goodrich plant, WSOR 501003 was observed turned over on its left side (direction of movement of the train). The A-end truck was separated from the car and was found about 50 feet south of the derailed car. The B-end truck, which was the lead truck in the direction of movement of the train, was also separated from and in line with the car. Heavy rail burns were observed on the left sideframe of the B-end truck and wheel marks were observed on the left side cross-ridge slope sheet of the car (figure 12). Additionally, the lead wheelset showed evidence of heavy chaffing and bluish discoloration on the steel rims and flanges. Some of the springs were dislodged from the right sideframe of the B-end truck assembly. Figure 13 identifies some pertinent components of a truck assembly, including the bolster and sideframes.

Rule 47(B)(1)(a) of the Field Manual of the AAR Interchange Rules adopted by the AAR's Mechanical Division, Operations and Maintenance Department, states that truck bolsters must not be used if they do not have AAR identification marks or pattern numbers. Rule 47(B)(2) states that truck bolsters arranged for "wide land" bolster rotation stops are not interchangeable with bolsters incorporating the standard rotation lug. The B-end truck bolster on car WSOR 501003 (Gould-B-9S-14EJ-BX) was a wide land design, and it did not have AAR identification marks or pattern numbers.³⁴

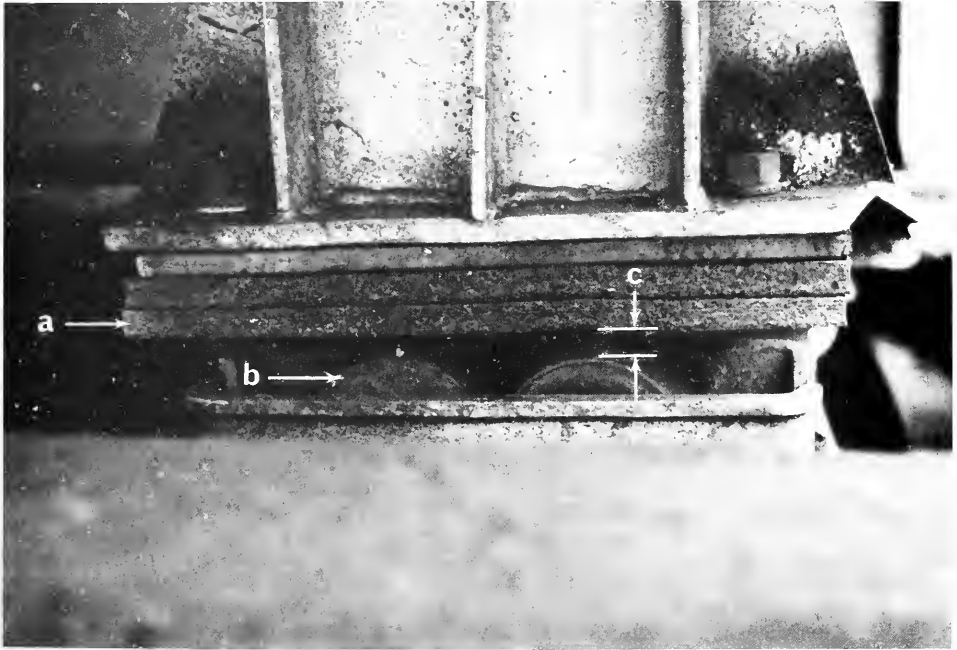
Figure 16.--Components of a side bearing: (A) the side bearing plate attached to the car body bolster, (B) the roller attached to the truck, and (C) the side bearing clearance in-between.

After car WSOR 501003 was rerailed and after its load of sand was leveled, the side bearing clearances were measured. (A side bearing clearance is the distance between a side bearing roller on a truck and a side bearing plate attached to the car body bolster above the roller; this clearance is illustrated in figure 16.) (One of the two truck side bearing rollers on the A-end right side was missing.) The measurements were as follows:

- (1) Part of the side bearing assembly is missing or broken;
- (2) The bearings at one end of the car, on both sides, are in contact with the body bolster (except by design);
- (3) The bearings at one end of the car have a total clearance from the body bolster of more than 3/4 (12/16) of an inch; and
- (4) At diagonally opposite sides of the car, the bearings have a total clearance from the body of more than 3/4 (12/16) of an inch.

³⁵ Maximum clearance permitted by FRA regulations is 3/4 (12/16) inch. There is no minimum clearance; however, constant contact is not permitted for the type of bearing used on WSOR 501003.

The Field Manual of the Interchange Rules of the AAR, Rule 47(E)(2), however, states that side bearings must have 3/16-inch minimum to 5/16-inch maximum clearance. (This clearance does not apply to constant-contact type side bearings.) The AAR considers the FRA regulations to be safety standards, and it considers the AAR rules to be maintenance standards that are designed to identify and correct problems before the FRA regulations are violated. The AAR considers the FRA maximum side bearing clearance to be safe.
